**Wetland and Waterbodies Delineation Report**

**LOU GEHRIG FIELD PARKING**

**Town of Amherst**

**REPORT SUMMARIZING  
THE RESULTS OF  
A WETLAND DELINEATION SURVEY OF**

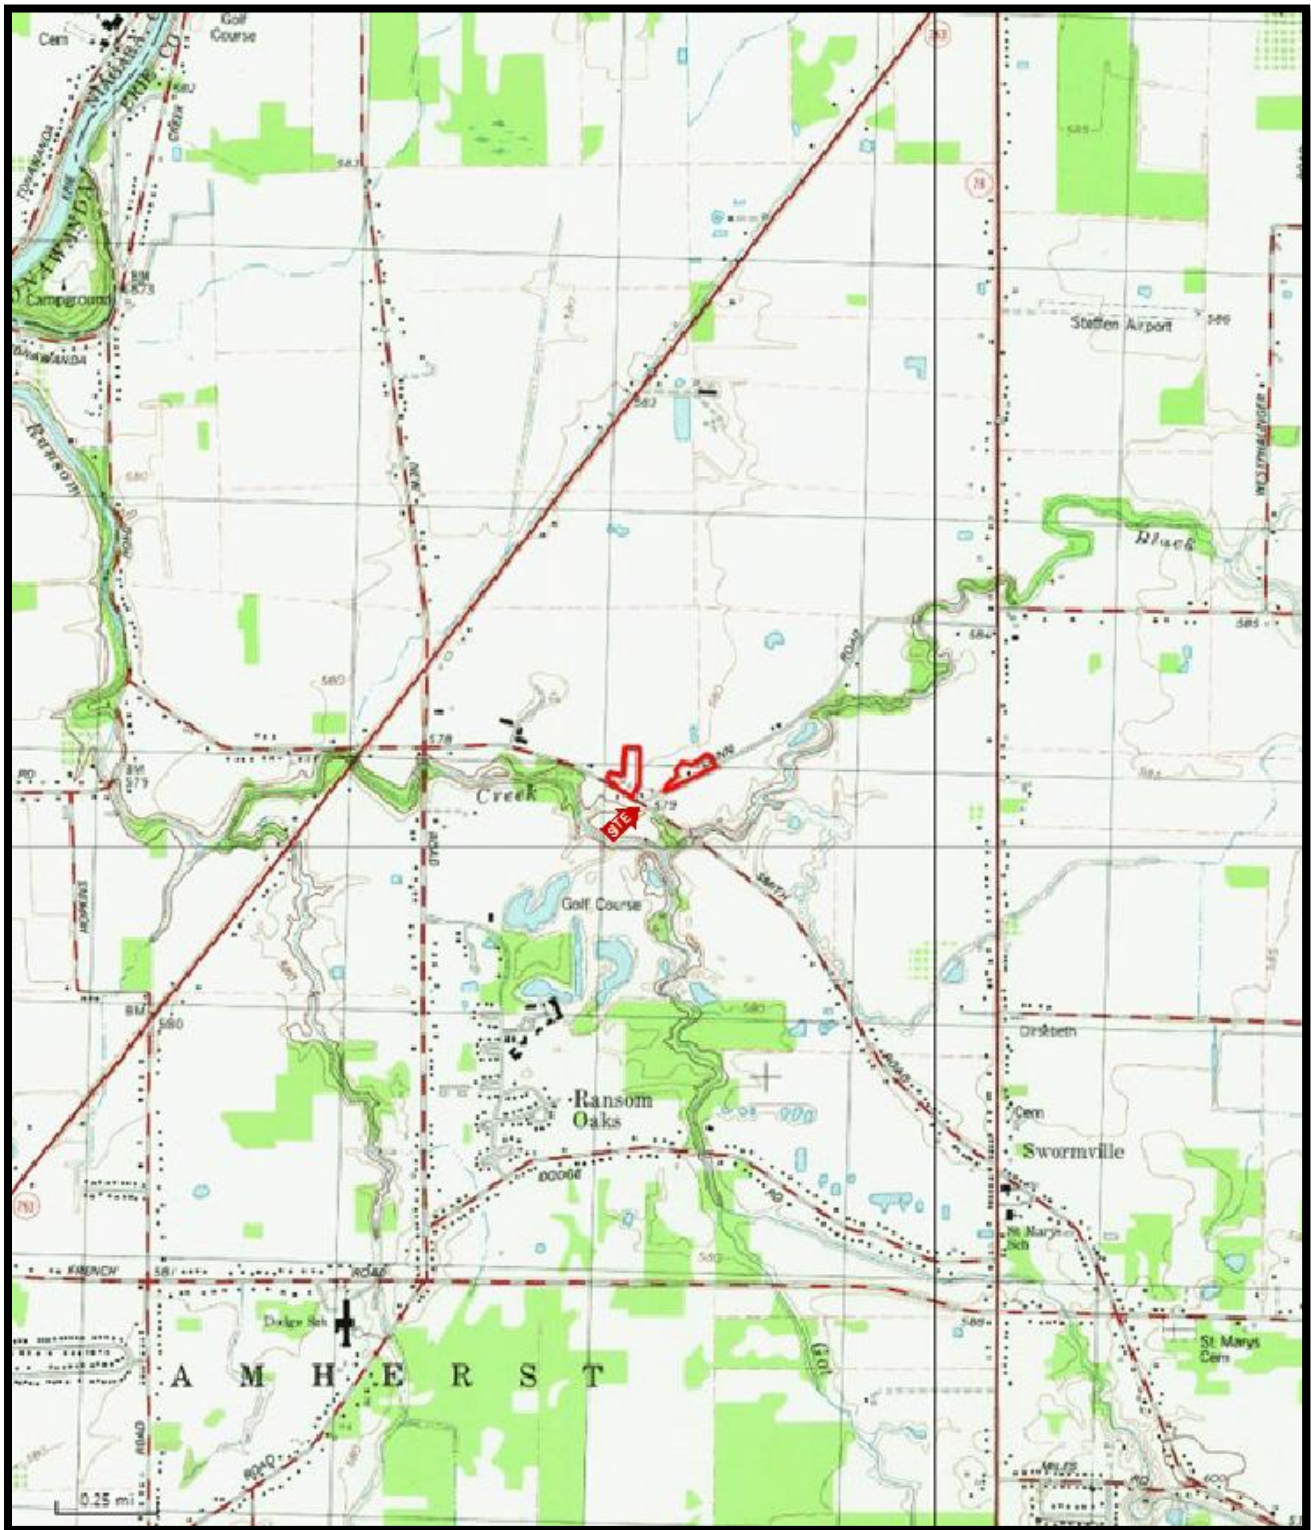
**FIGURE 1: USGS 7.5 MINUTE TOPOGRAPHICAL MAP**

Figure 1 depicts the Lou Gehrig Field Parking project site on the Clarence Center quadrangle map. The figure depicts the flat topography of the site. No drainage features are depicted within the investigation area.

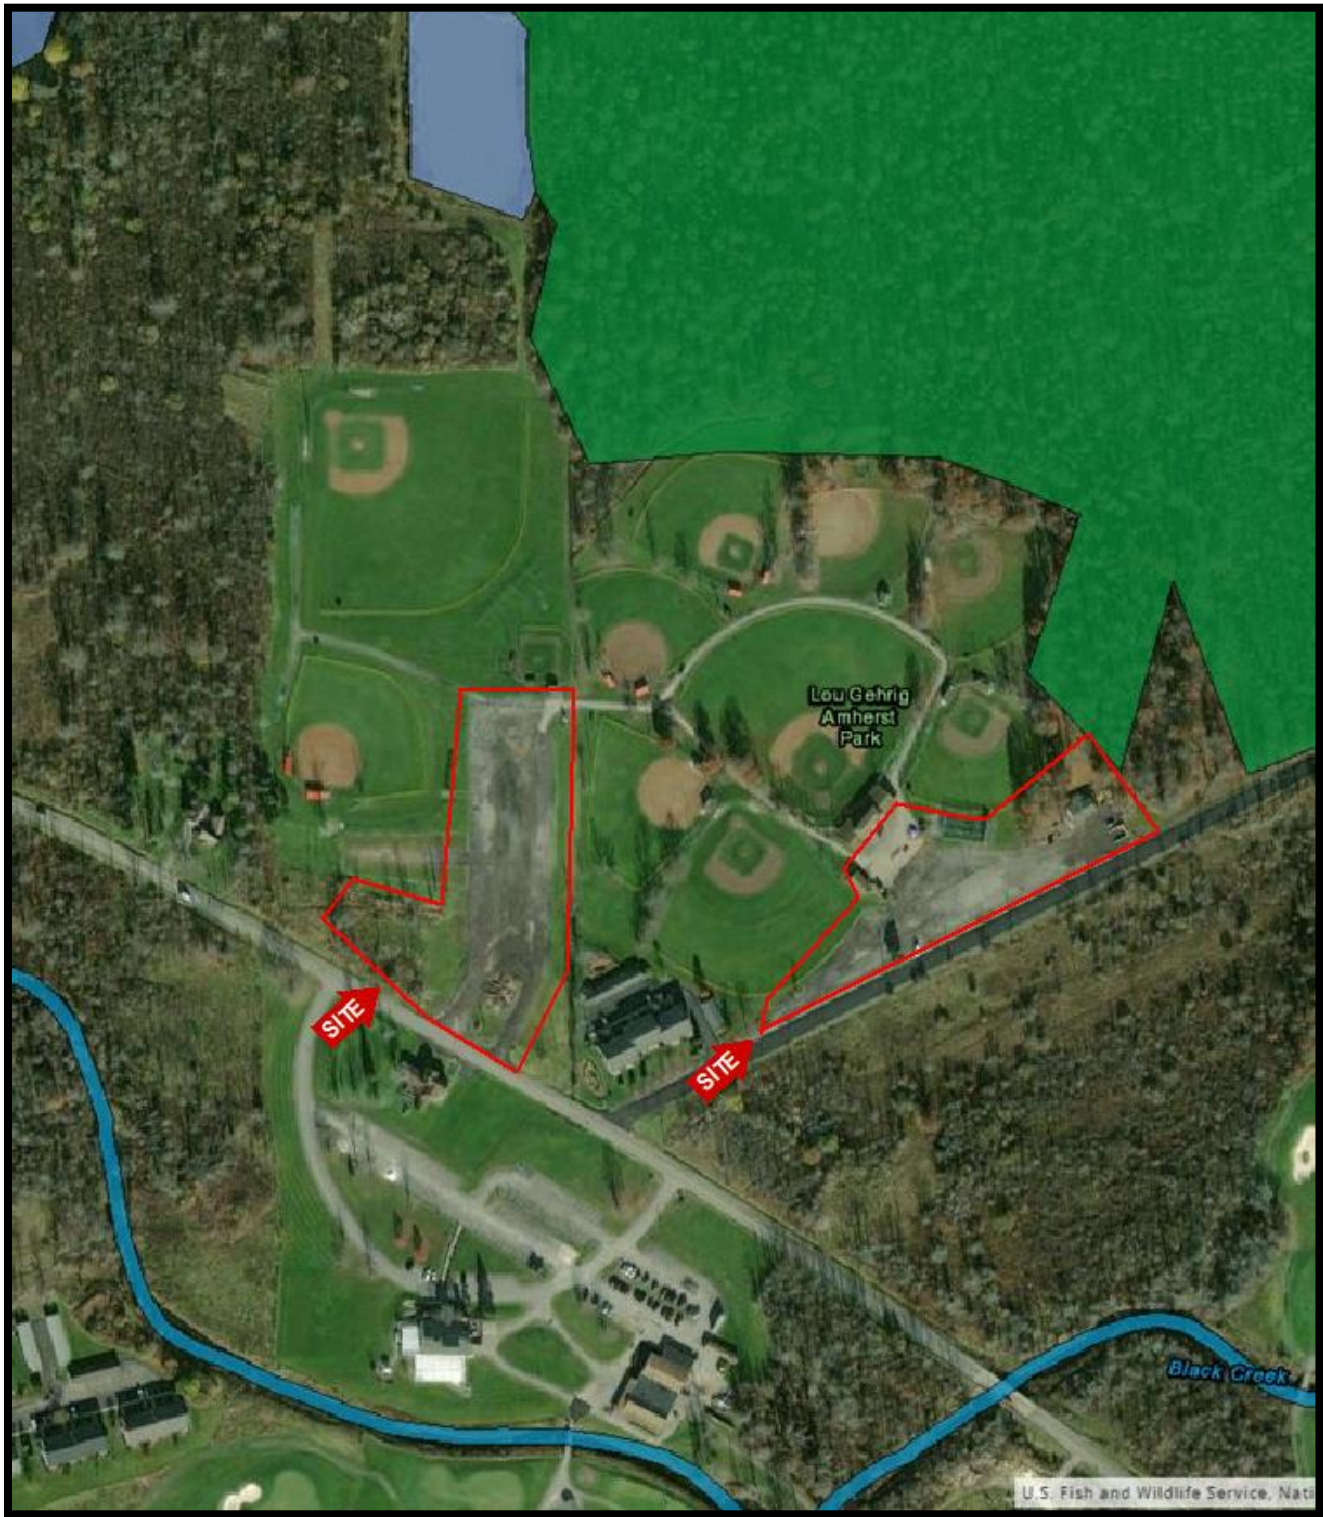
**FIGURE 2: NATIONAL WETLANDS INVENTORY MAP**  
<http://www.fws.gov/wetlands/data/mapper.HTML> (Visited 4/21/22)

The National Wetlands Inventory (NWI) map obtained from the USFWS Wetland Mapper <http://www.fws.gov/wetlands/Data/Mapper.html> displays one (1) wetland type, PFO1B, near the eastern edge of the investigation area. The wetland can be decoded as:  
[P] Palustrine, [FO] Forested, [1] Broad leaved-deciduous, [B] Saturated

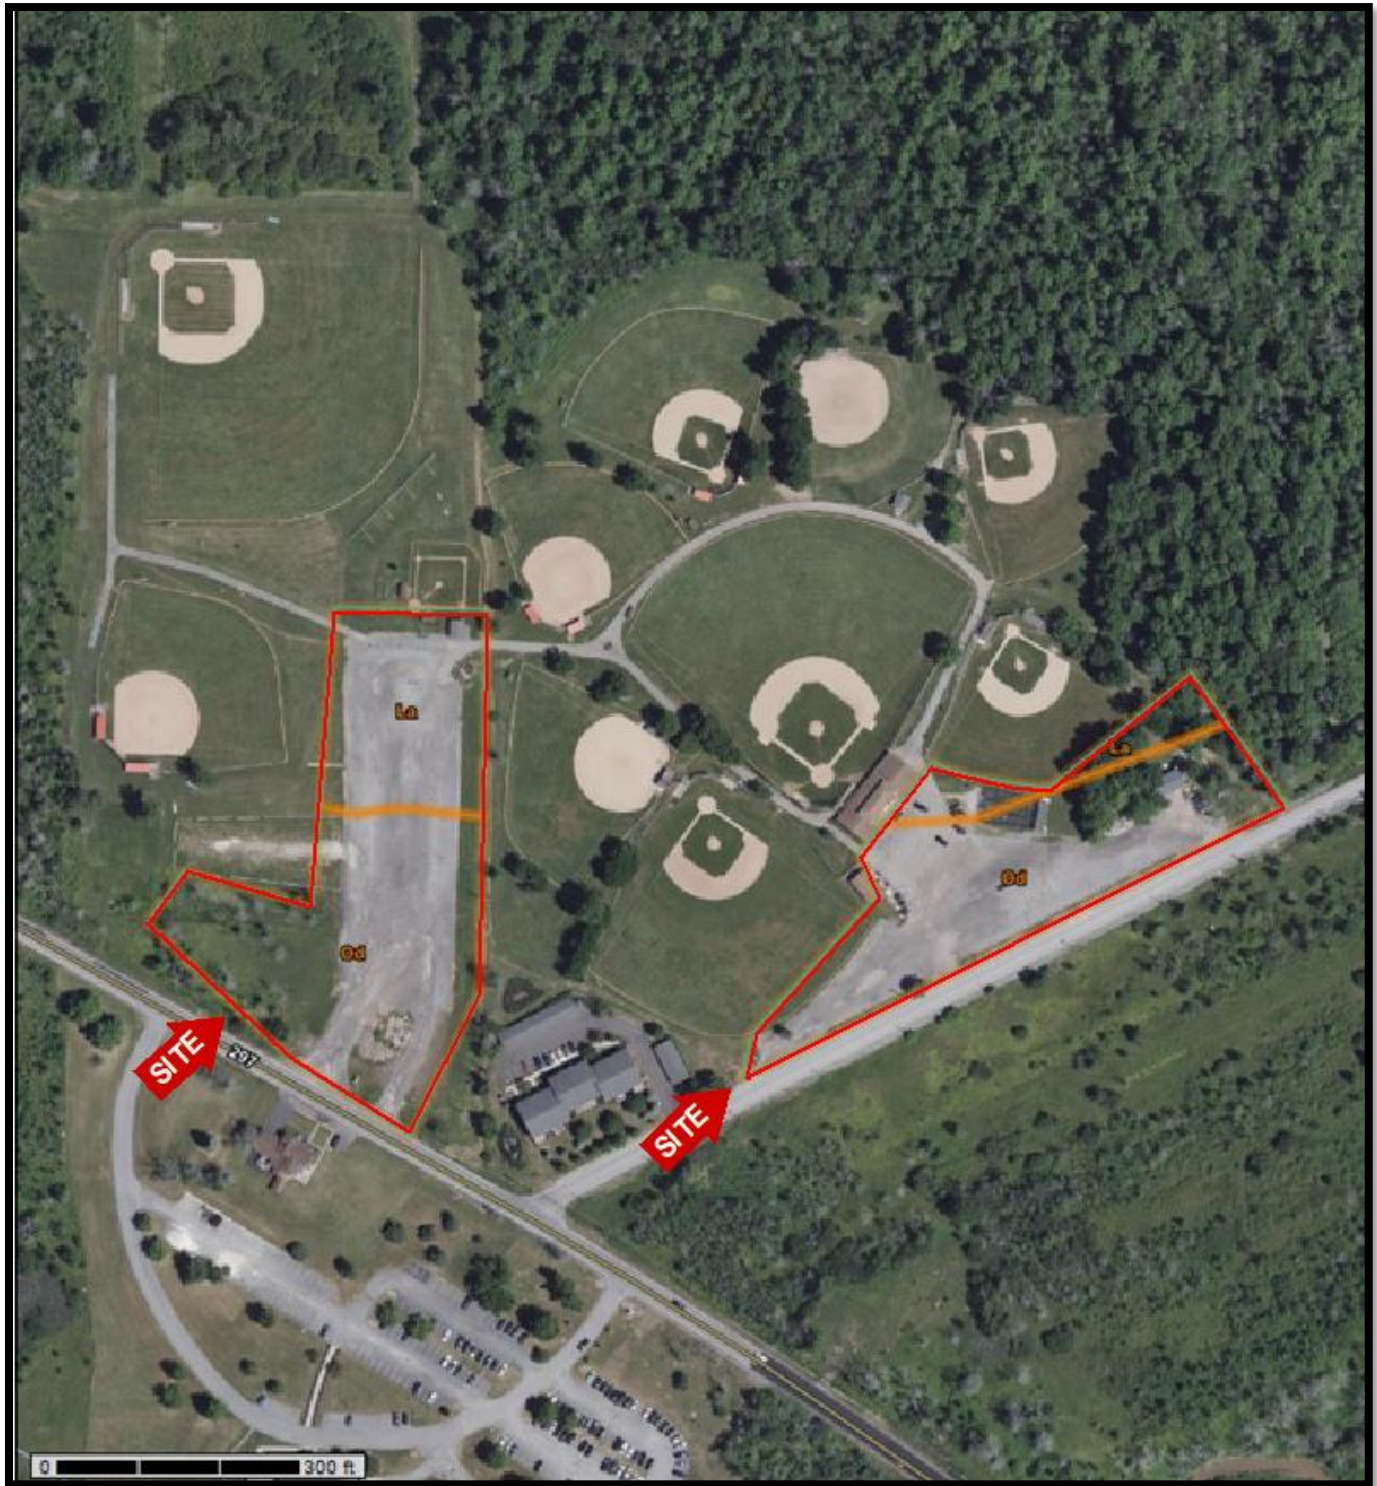
**FIGURE 3: NRCS ERIE COUNTY SOIL SURVEY MAP**

Figure 3 presents the project area outlined on a copy of the Erie County Soil Survey map from the National Cooperative Soil Survey. As shown on that figure, the site has the following soil types:

Map Unit Symbol	Map Unit Name	Hydric Rating
La	Lakemont silt loam, 0 to 3% slopes	95
Od	Odessa silt loam, 0 to 3% slopes	5

NRCS map (Figure 3). The preliminary data review indicated that NYSDEC may have jurisdiction over wetlands on site as depicted on the NYSDEC Resource Mapper (Figure 4). Therefore, it was considered necessary to perform a field investigation at the site in order to determine the presence of federal and state protected wetlands. The methods specified in the Corps of Engineers Wetlands Delineation Manual (January 1987) and Northcentral and Northeast Regional Supplement Version 2.0 (January 2012) were employed during the field investigation. Procedures, results, and conclusions of the wetland delineation study are presented in the remainder of this report.

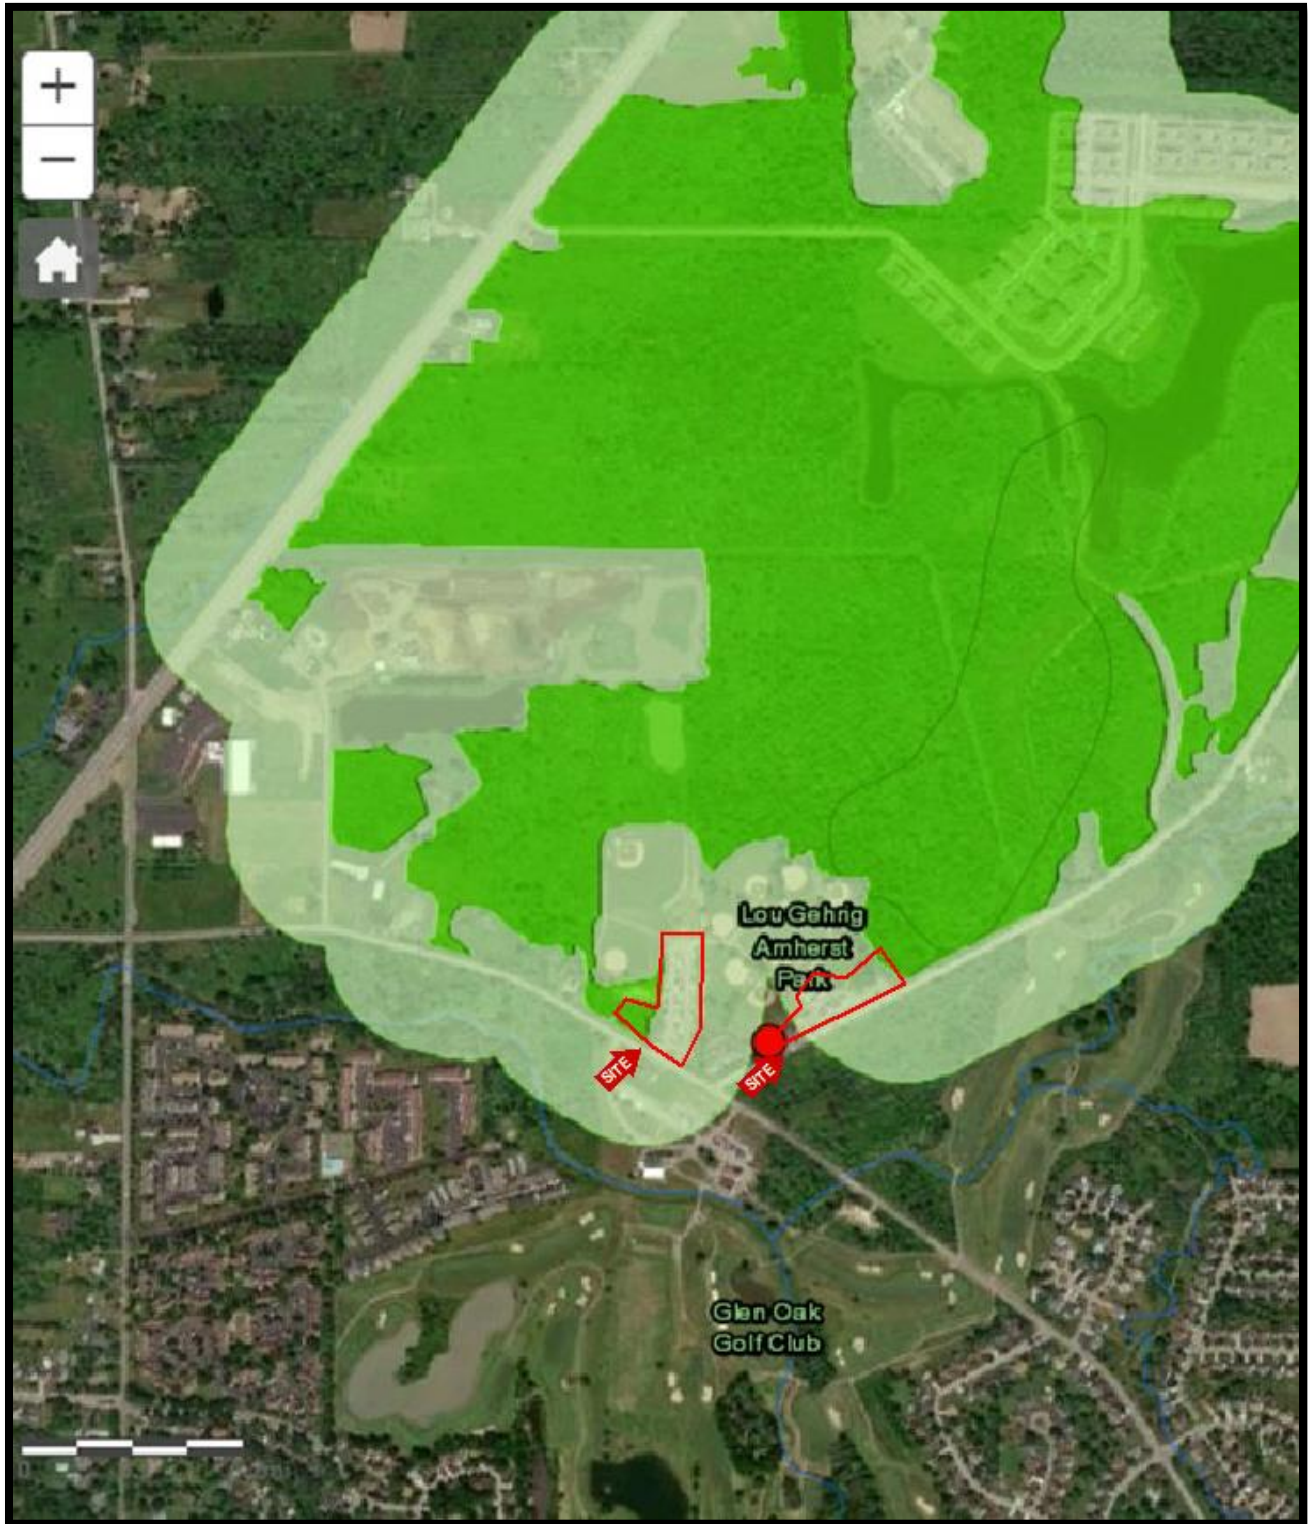
**FIGURE 4: NYSDEC ENVIRONMENTAL RESOURCE MAPPER**  
<http://www.dec.ny.gov/ismaps/ERM/viewer.htm> (Visited 4/21/22)

The NYSDEC Freshwater Wetlands map obtained from the online NYSDEC Environmental Resource Mapper displays state jurisdictional Freshwater Wetland CC-45 within and adjacent to the investigation area.

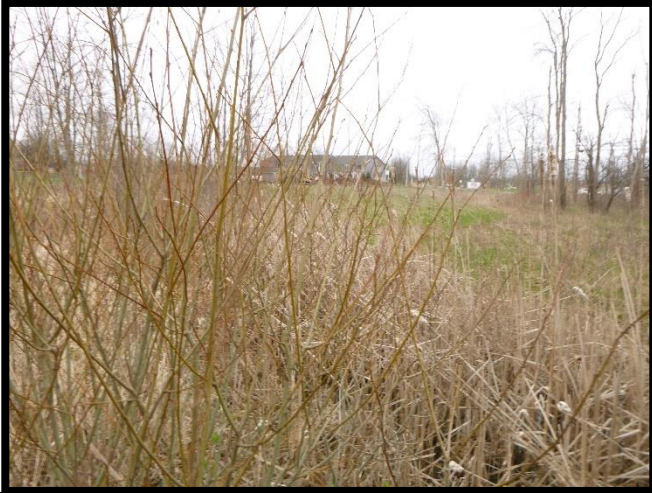
Wetland W1 is a  $0.23\pm$  acre emergent marsh/scrub-shrub swamp dominated by pussy willow (*Salix discolor*), narrowleaf cattail (*Typha angustifolia*) and common rush (*Juncus effusus*). The community is predominantly emergent with scattered shrubs and saplings beginning to dominate. Soils within wetland W1 are mapped as Odessa silt loam and had a topsoil color of 7.5YR3/1 and a subsoil color of 7.5YR5/1 with 5% 7.5YR5/8 mottles. The texture is silty clay loam and silty clay. This soil fits the NRCS F3 indicator (Depleted Matrix). Hydrology indicators present in Wetland W1 included surface water (A1), saturation (A3) and Water-Stained Leaves (B9). It is EDI's professional opinion that Wetland W1 is Federally jurisdictional under the currently applicable post-Rapanos Rule due to a

**Photo 1:** Facing east. Depicts the emergent marsh/scrub-shrub swamp community of wetland W1 at data point D1.

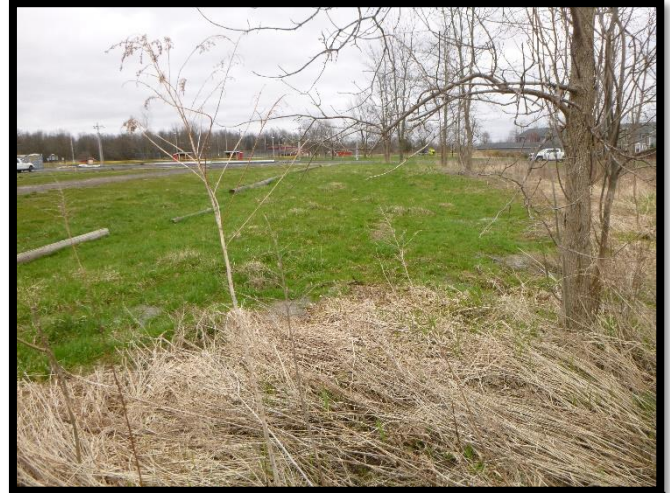
**Photo 2:** Facing east. Depicts the successional old field and mowed lawn communities at data point D2.

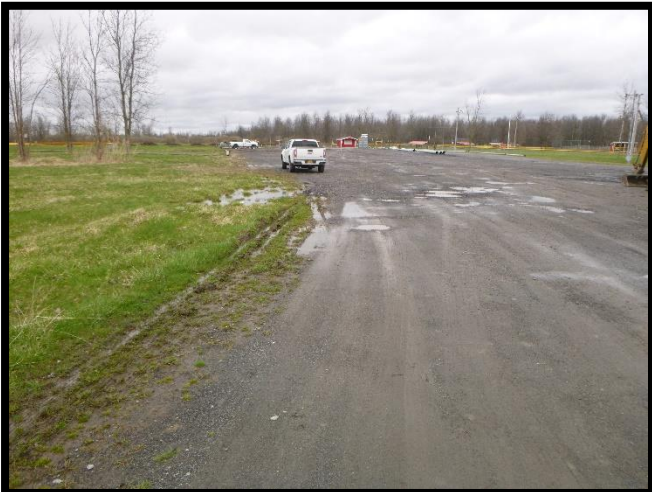
**Photo 3:** Facing north. Depicts the existing parking area in the western investigation area.

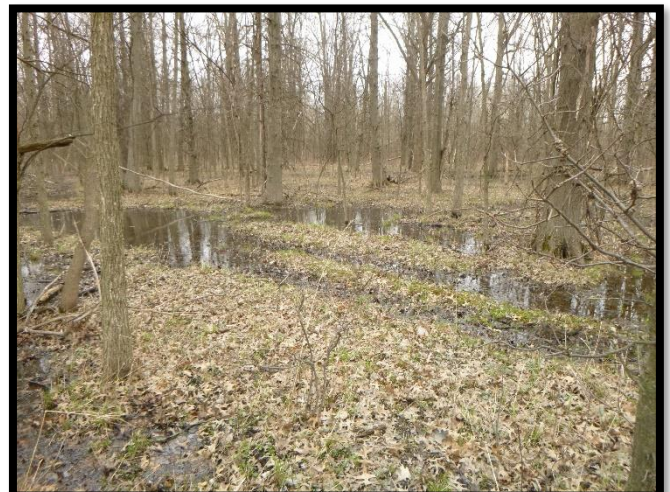
Wetland W2 is a 0.07± acre hardwood swamp dominated by pin oak (*Quercus palustris*), American elm (*Ulmus americana*), creeping Jenny (*Lysimachia nummularia*), reed canarygrass (*Phalaris arundinacea*) and upright sedge (*Carex stricta*). Soils within wetland W2 are mapped as Lakemont silt loam and had a topsoil color of 7.5YR3/1 and a subsoil color of 7.5YR5/1 with 15% 7.5YR5/8 mottles. The texture is silt loam and silty clay loam. This soil fits the NRCS F3 indicator (Depleted Matrix). Hydrology indicators present in Wetland W1 included surface water (A1), high water table (A2), saturation (A3) and Water-Stained Leaves (B9). It is EDI's professional opinion that Wetland W2 is Federally jurisdictional under the currently applicable post-Rapanos Rule due to a significant nexus to a traditionally navigable water. It is also EDI's professional opinion that wetland W2 is connected to NYSDEC Freshwater Wetland CC-45 and is jurisdictional under Article 24.

**Photo 4:** Facing northeast. Depicts the hardwood swamp community of wetland W2 at data point D3.

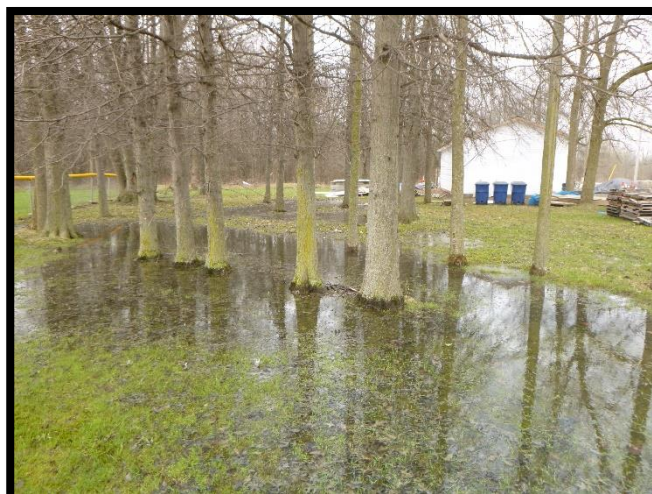
Wetland W3 is a 0.09± acre hardwood swamp dominated by pin oak (*Quercus palustris*). It is EDI's professional opinion that Wetland W3 is Federally jurisdictional under the currently applicable post-Rapanos Rule due to a significant nexus to a traditionally navigable water. It is also EDI's professional opinion that wetland W3 is connected to NYSDEC Freshwater Wetland CC-45 and is jurisdictional under Article 24.

**Photo 5:** Facing east. Depicts the hardwood swamp community of wetland W3.

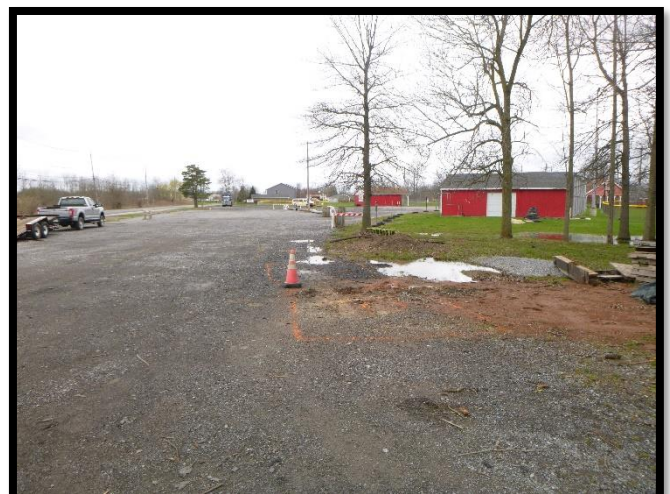
**Photo 6:** Facing west. Depicts the existing parking area in the eastern investigation area.
