SUBJECT: Preliminary Jurisdictional Determination and Approved Jurisdictional Determination for Department of the Army Application No. 2003-00052 (Uniland Construction - 3750 and 3800 Millersport Highway)

I have reviewed the wetland delineation report submitted on your behalf by Wilson Environmental Technologies for a wetland boundary verification for a parcel located at 3750 & 3800 Millersport Highway, Town of Amherst, Erie County, New York.

EDI has performed a wetland delineation study at the site under guidelines specified by the *Corps of Engineers Wetlands Delineation Manual*, dated January 1987 (referred to hereafter as the Corps Manual). The purpose of this report is to present EDI's methods, results, conclusions and recommendations with respect to the Asbury United Methodist Church project site.

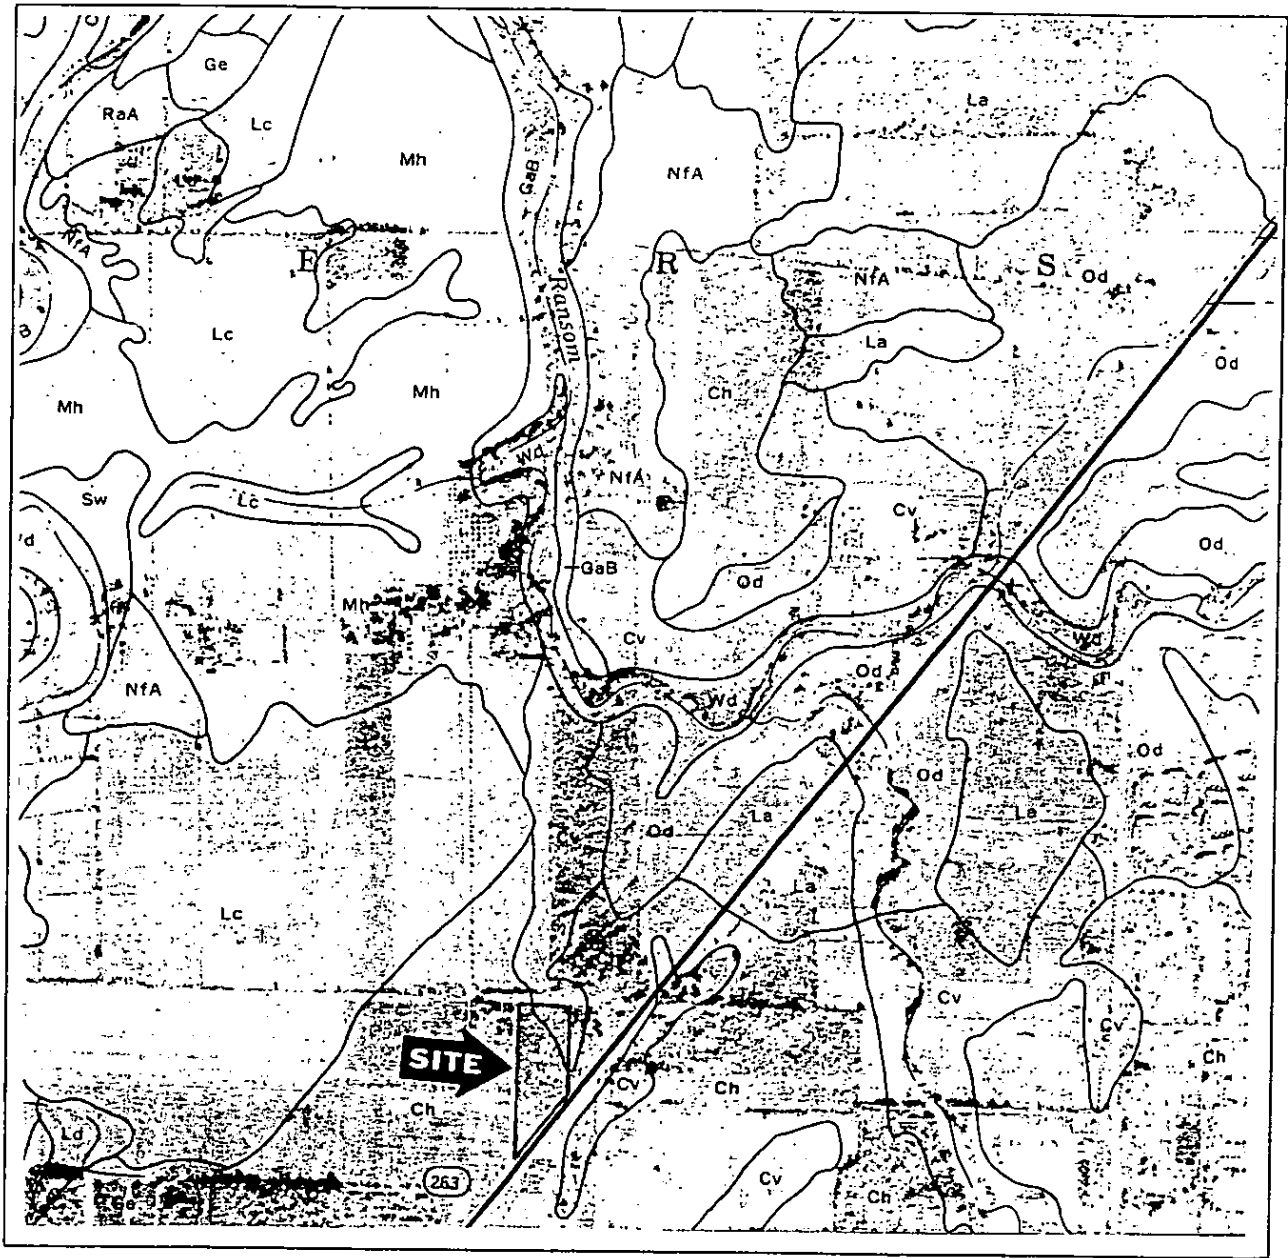
Figure 3: SCS Erie County Soil Survey Map
Sheet Number 9

Field examination of the soil on the site showed general agreement to the published SCS soil map (Figure 3). Cosad soil was identified throughout the majority of the site (data points D1-5) during the investigation. The wetland areas were found to be underlain by Cheektowaga soil (data point D7) and Udorthents soil fill (data point D6).

General site maps are presented in Attachment A, Figures 5 and 6 that show the soil types and major plant communities found on the property.
