# Wetland and Waterbodies Delineation Report

# 5500 MILLERSPORT HIGHWAY

Town of Amherst

**REPORT SUMMARIZING  
THE RESULTS OF  
A WETLAND DELINEATION SURVEY OF**

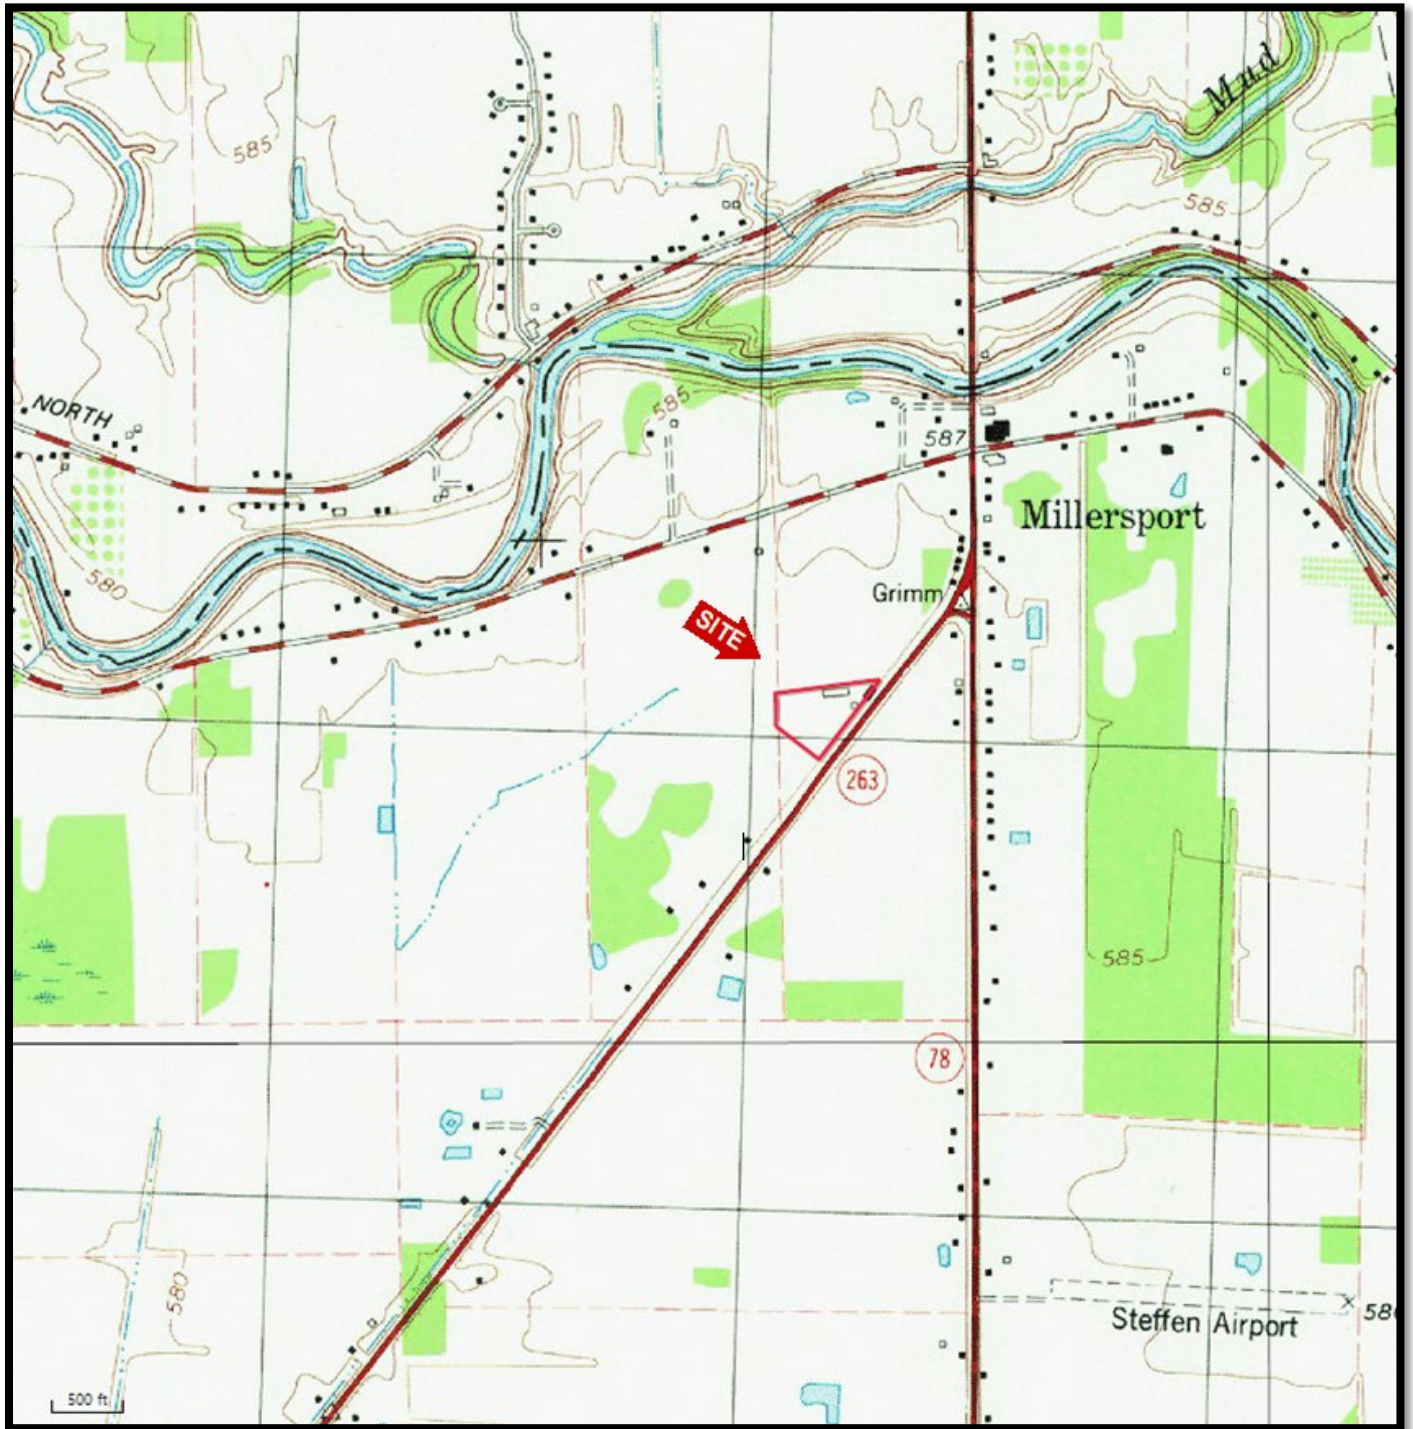
**FIGURE 1: USGS 7.5 MINUTE TOPOGRAPHICAL MAP**

The USGS quadrangle map (Figure 1) depicts the investigation area on the Clarence Center quadrangle map. The figure depicts the flat topography of the site.

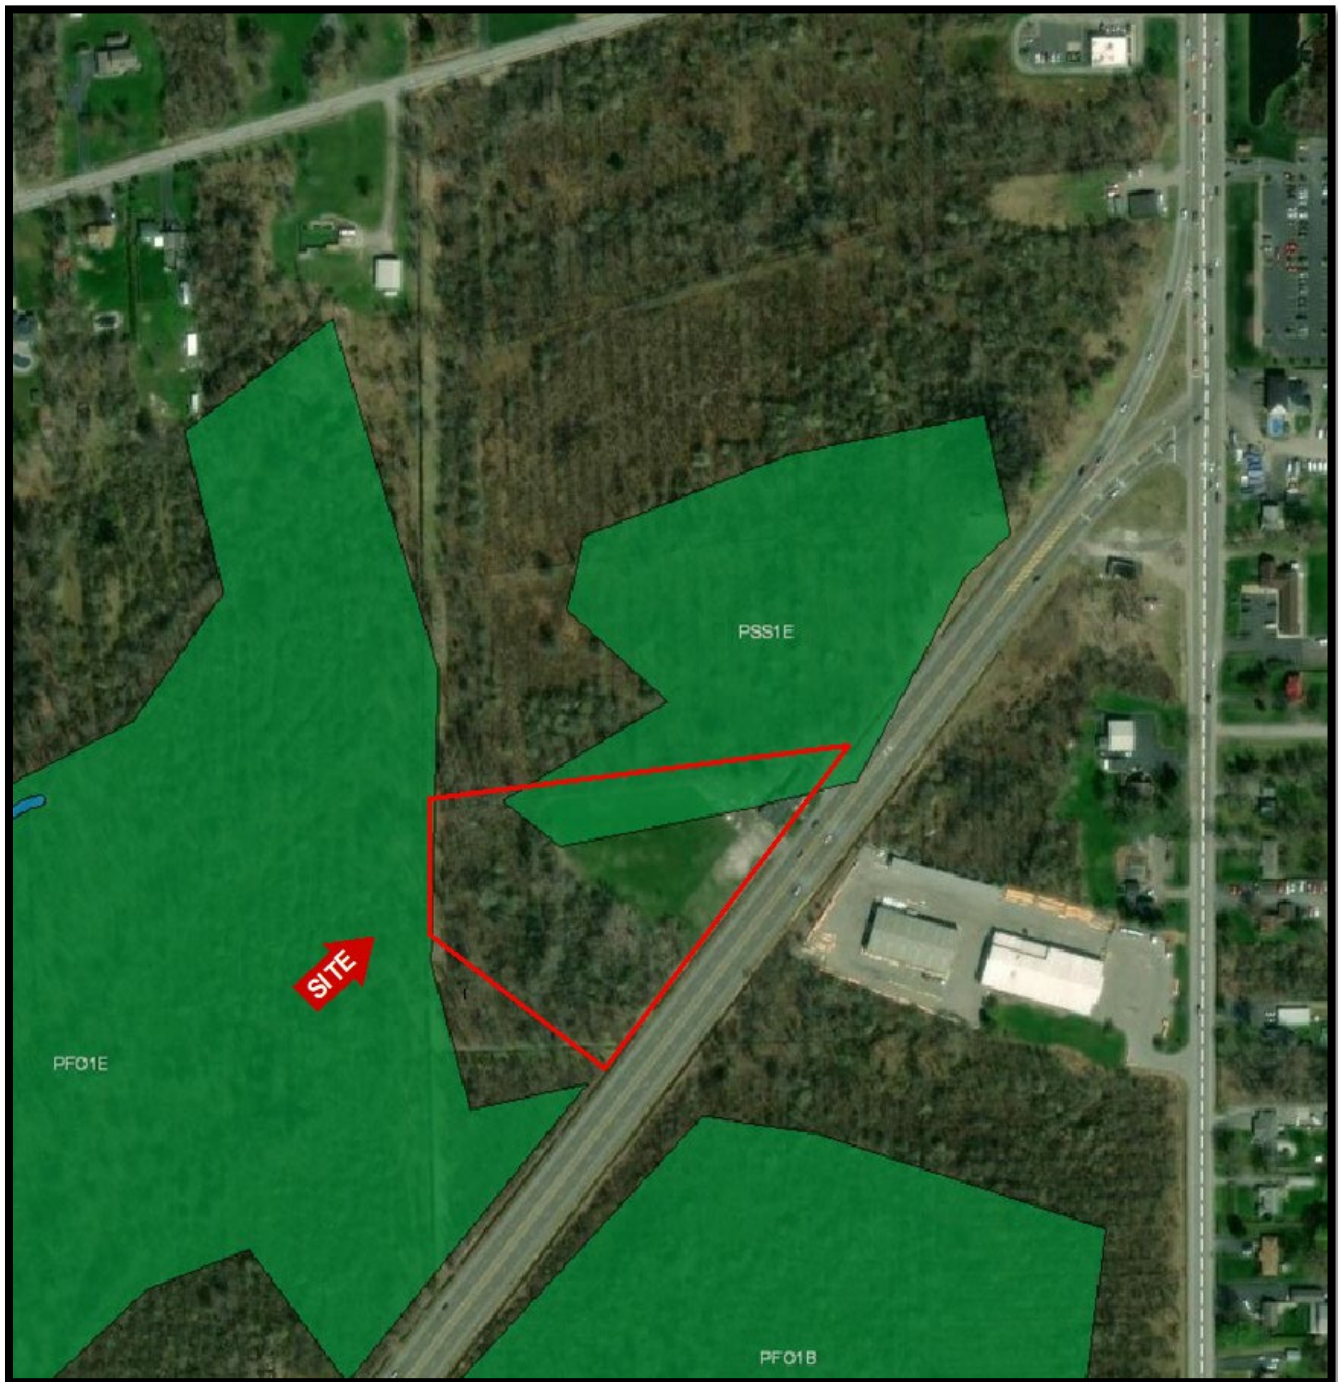
**FIGURE 2: NATIONAL WETLANDS INVENTORY MAP**  
<http://www.fws.gov/wetlands/data/mapper.HTML> (Visited 9/6/24)  
5500 Millersport Highway  
Town of Amherst, Erie County, New York

The National Wetlands Inventory (NWI) map (Figure 2) obtained from the USFWS Wetland Mapper <http://www.fws.gov/wetlands/Data/Mapper.html> displays two (2) wetland types, PFO1E and PSS1E within the investigation area. The wetlands can be decoded as:

[P] Palustrine, [SS] Scrub-shrub, [1] Broad leaved-deciduous, [E] Seasonally flooded/saturated  
 [P] Palustrine, [SS] Scrub-shrub,[1] Broad leaved-deciduous, [E] Seasonally flooded/saturated

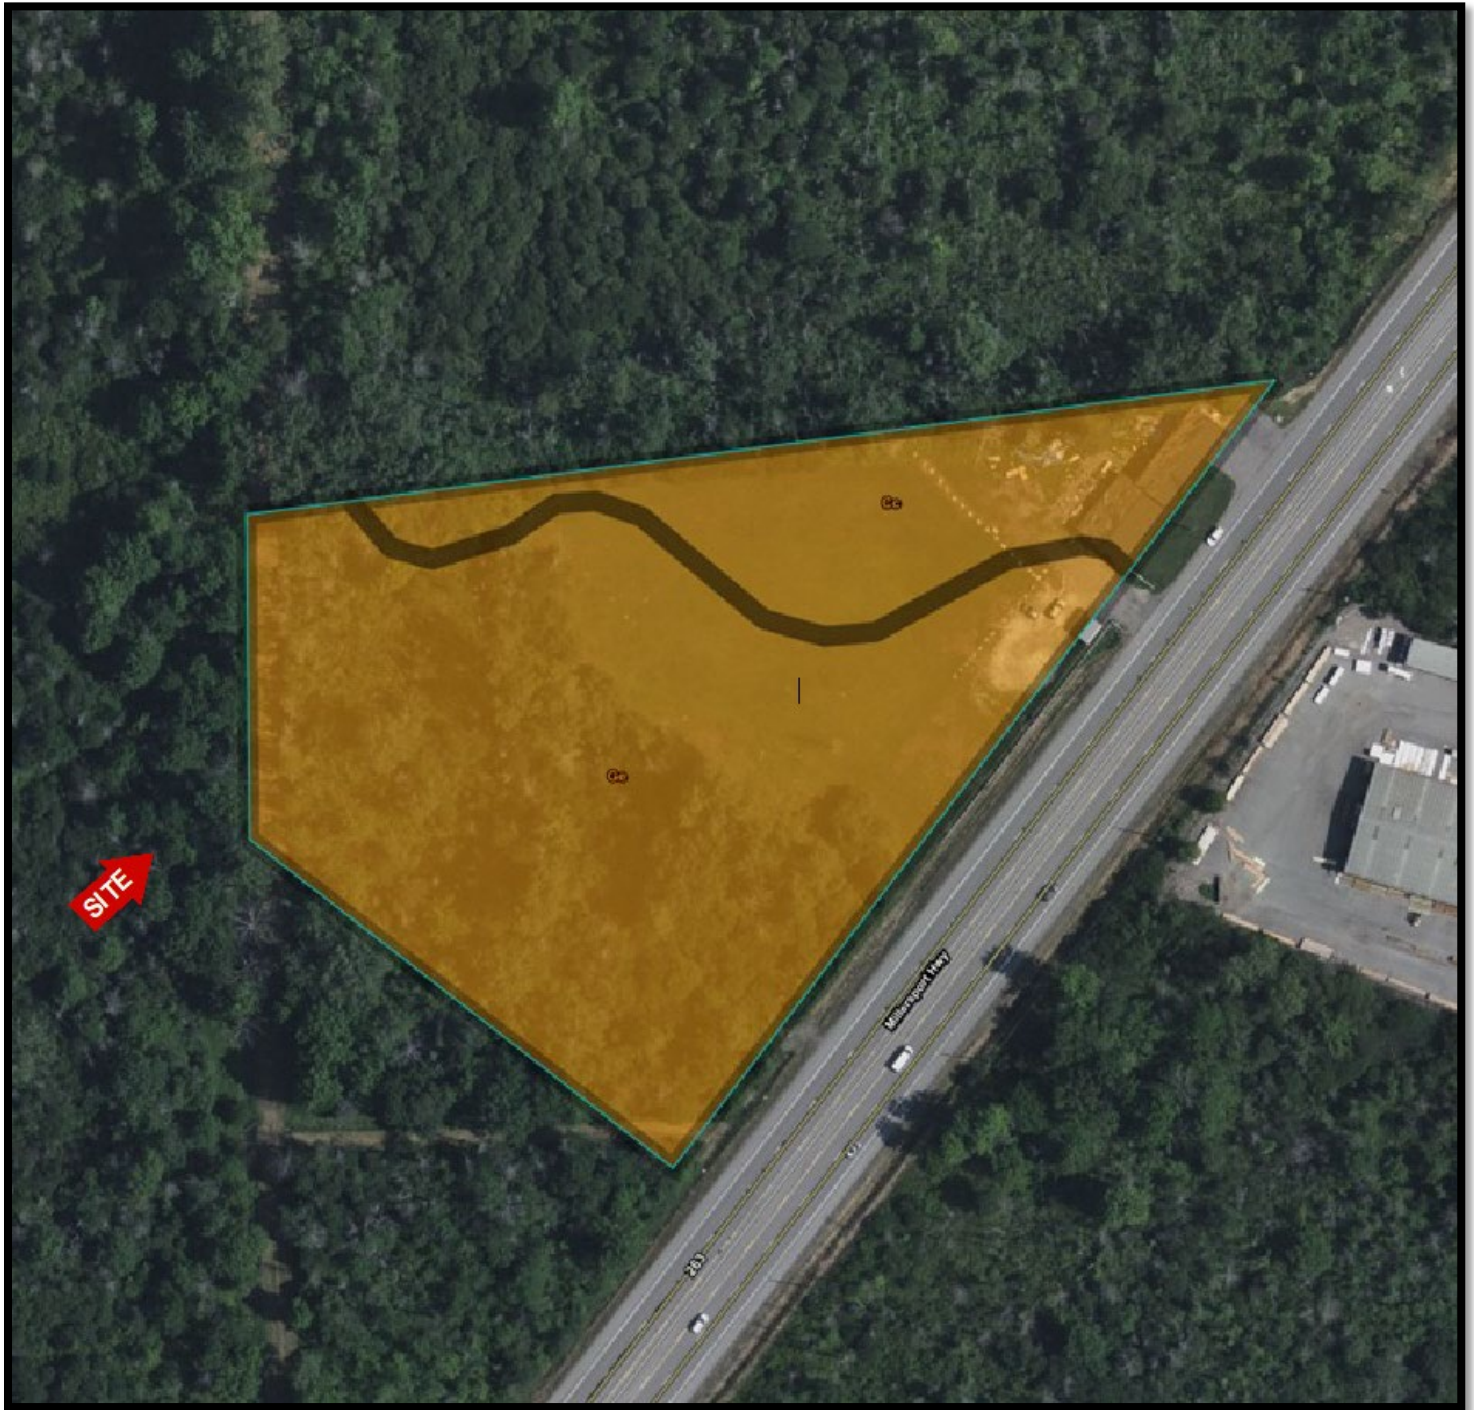
**FIGURE 3: NRCS SOIL SURVEY MAP**

The NRCS Soil Map (Figure 3) depicts the investigation area on the Erie County Soil Survey map obtained from the Web Soil Survey. As shown on that figure, the site has the following soil types:

Map unit symbol	Map unit name	Rating	Acres in AOI	Percent of AOI
Cc	Canandaigua silt loam	95	1.2	23.5%
Ge	Getzville silt loam	85	3.8	76.5%
<b>Totals for Area of Interest</b>			<b>4.9</b>	<b>100.0%</b>

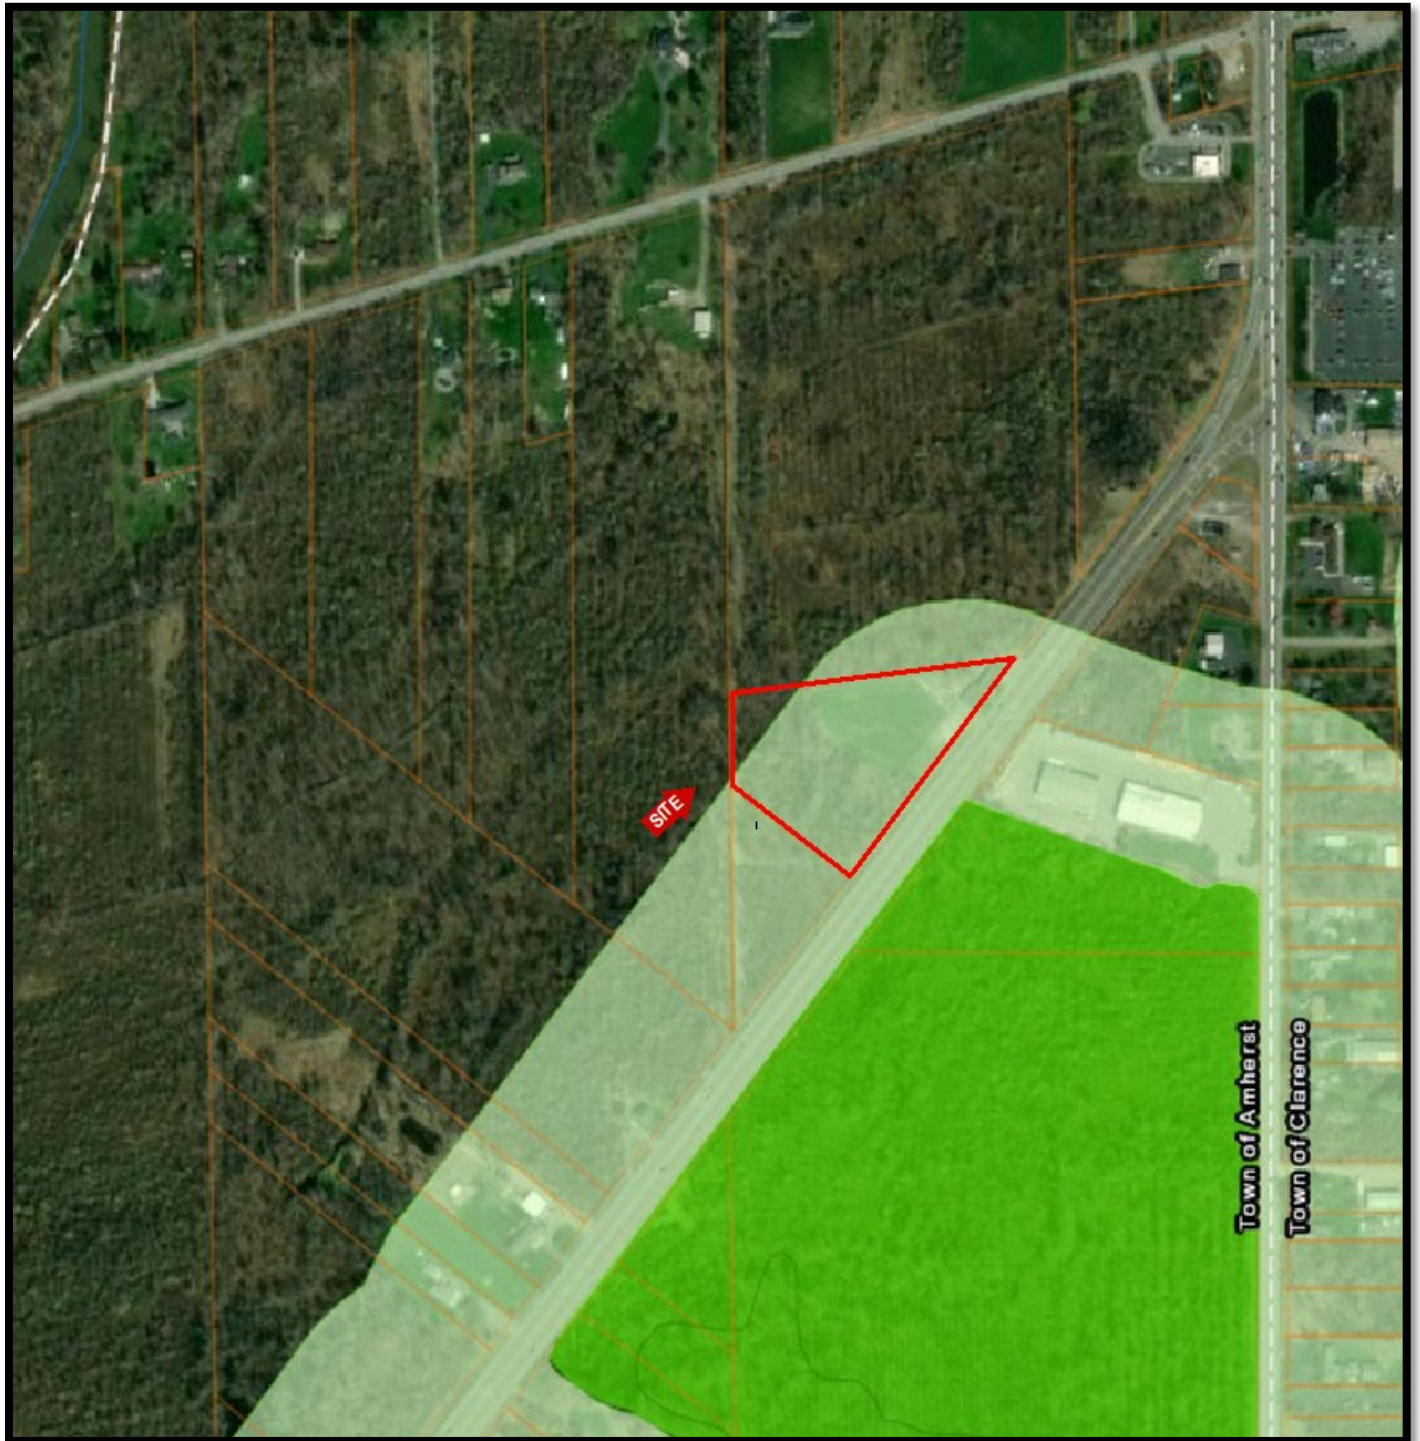
**FIGURE 4: NYSDEC ENVIRONMENTAL RESOURCE MAPPER**

The NYSDEC Freshwater Wetlands map (Figure 4) obtained from the online NYSDEC Environmental Resource Mapper displays the 500-foot check zone to state jurisdictional Freshwater Wetland CC-35 within and adjacent to the investigation area.

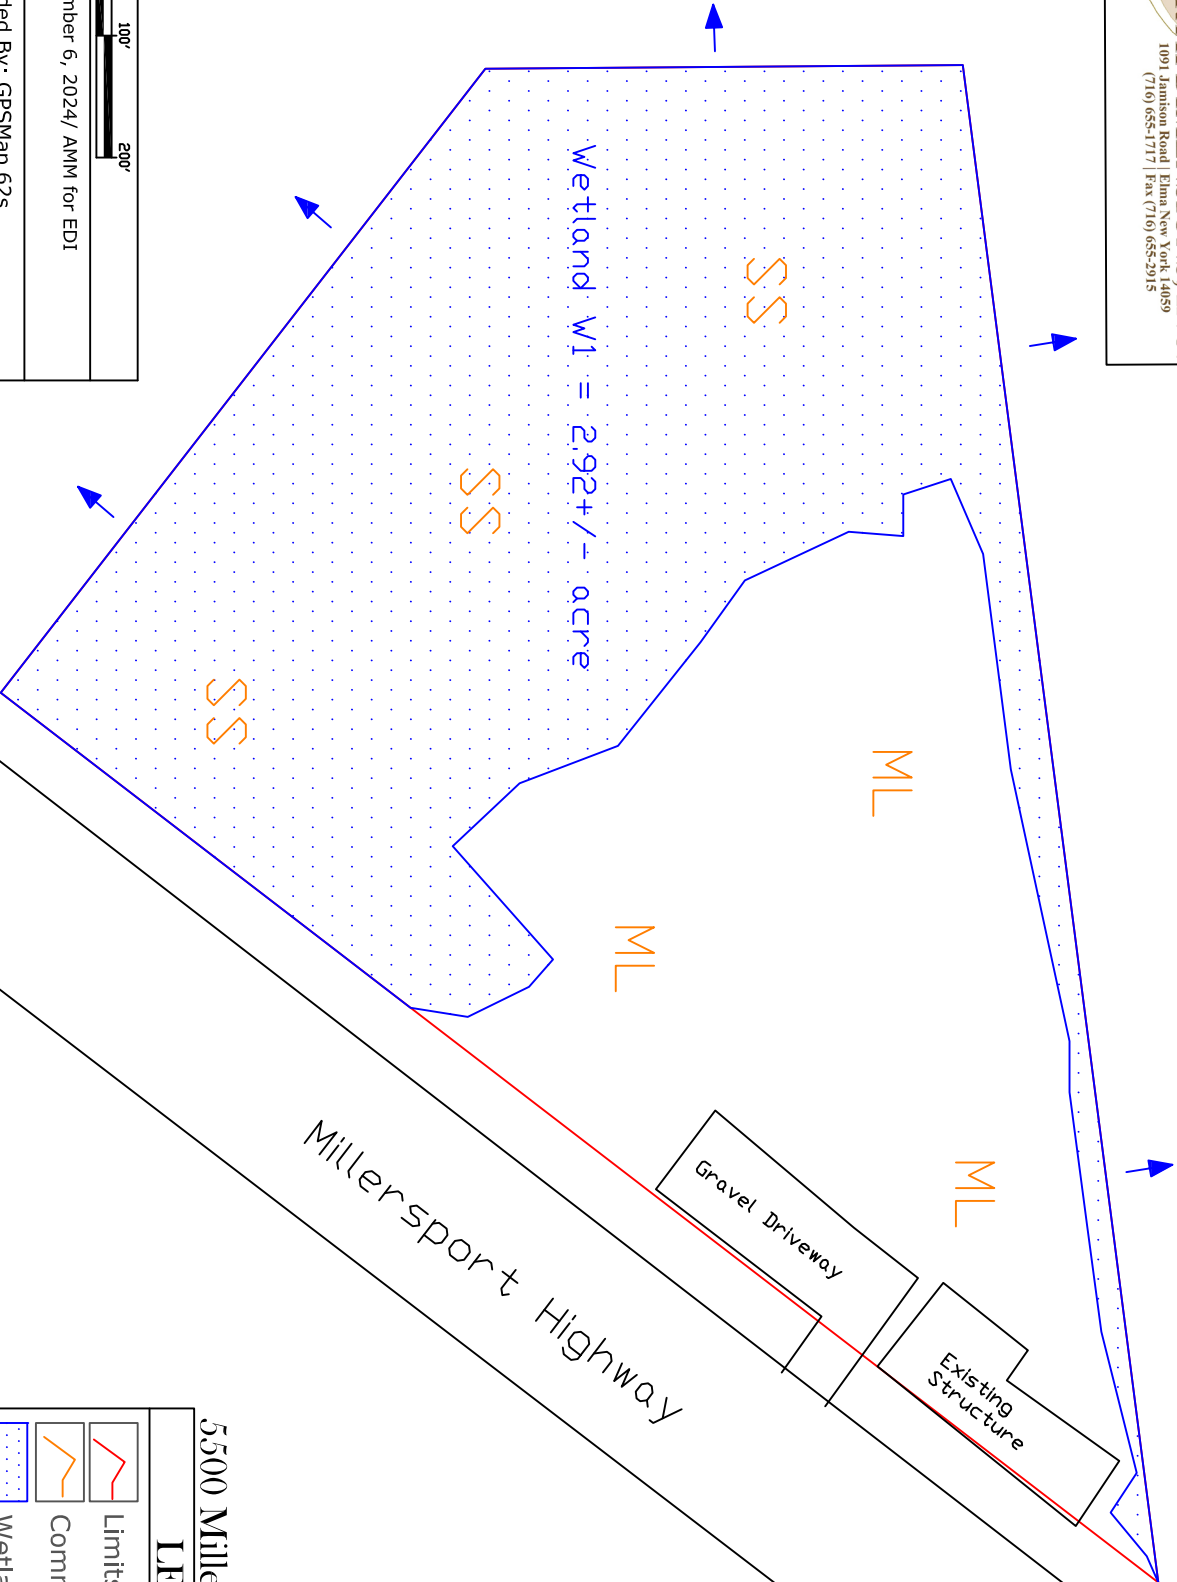
Figure 6 - Wetland Delineation Map

The 5500 Millersport Highway project area is comprised of a 4.92± acre irregular shaped investigation area on the north side of Millersport Highway and west of Transit Road which is outlined on Figure 1 and depicted on the Wetland Delineation Map included in Appendix A (Figure 6).

A map which depicts the site boundaries and the location of all observation points established during the field survey is included as Figure 6 in Appendix A of this report. Data forms are included as Appendix B. Appendix C includes representative photographs of the project area. Appendix D notes the references used during the preparation of this report and during the field investigation. Appendix E provides the names, addresses and phone numbers of the survey personnel involved in the wetland delineation study.

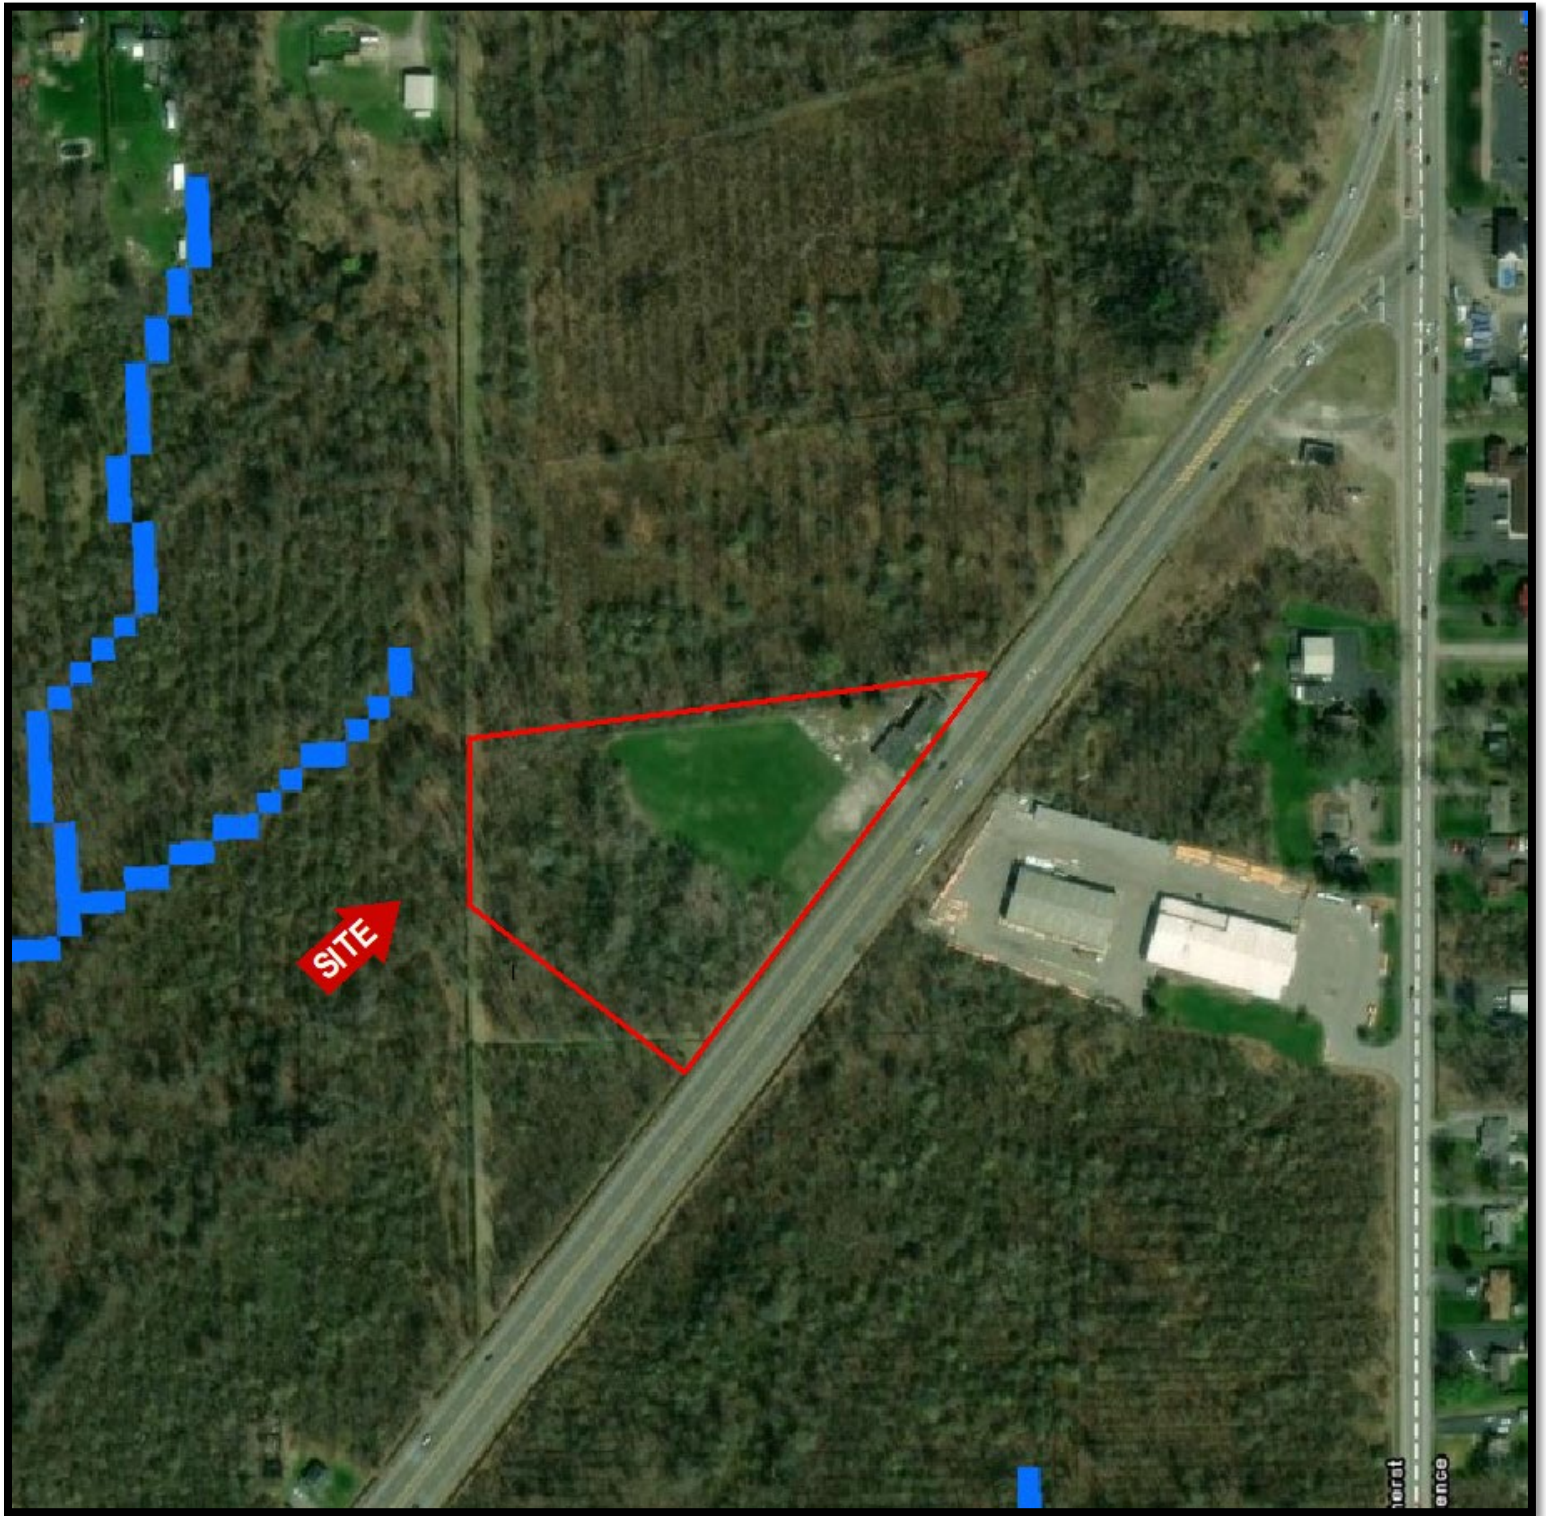
**FIGURE 7: DRAINAGE MAP**

The USGS StreamStats map (Figure 7) depicts no blue-line streams within the investigation area.

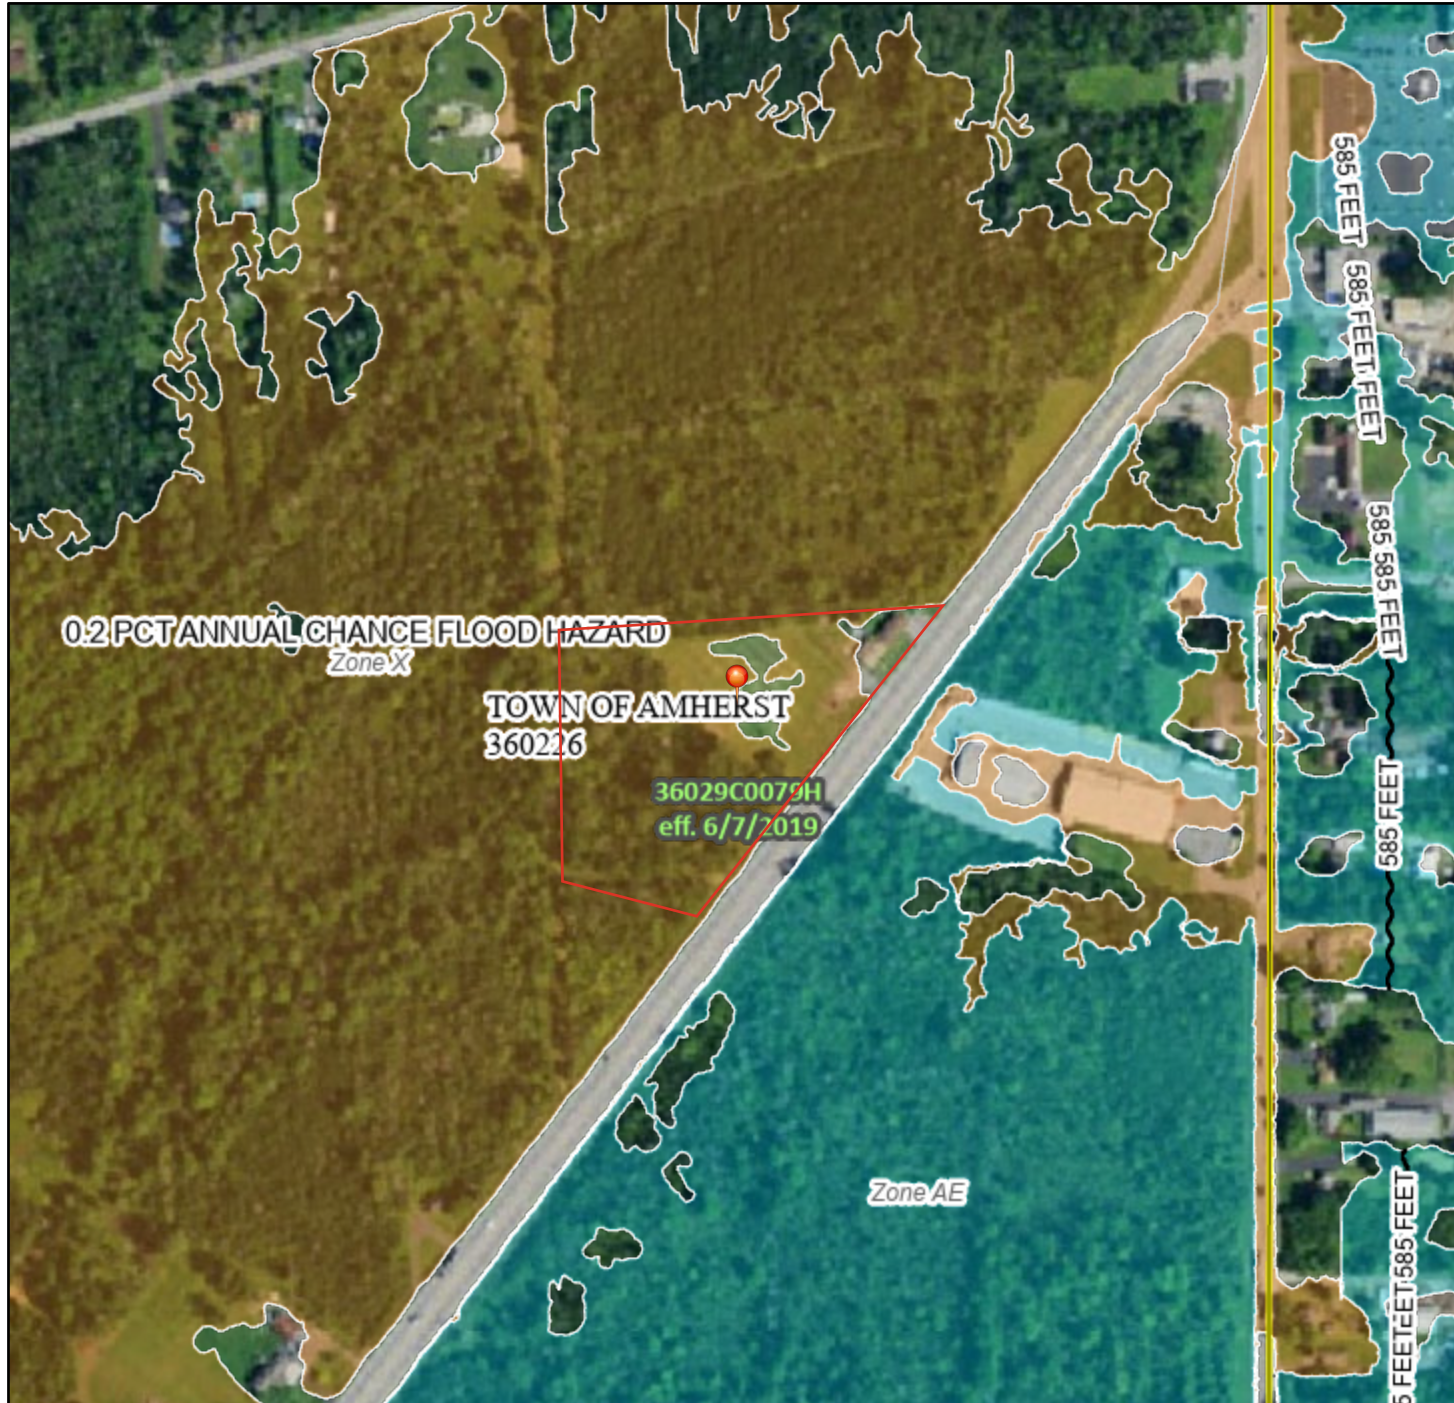
The Federal Emergency Management Agency (FEMA) flood map (Figure 11) obtained from the National Flood Hazard Layer on-line map shows the investigation area within a flood zone identified as X. This zone represents an area with a 0.2 percent annual chance flood hazard.

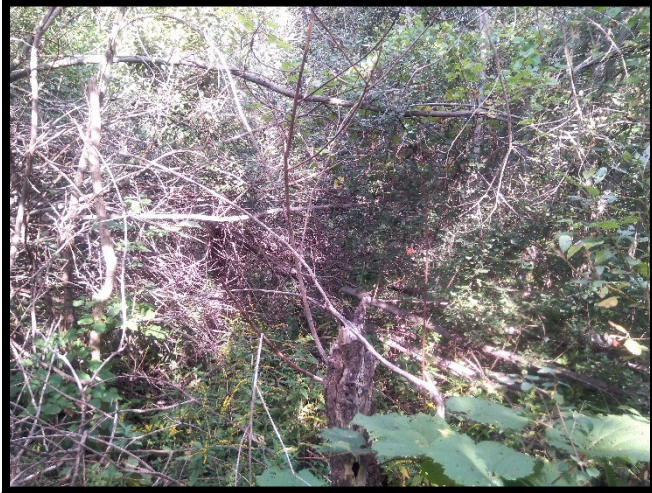
**Photo 1:** Facing northwest. Depicts the scrub-shrub swamp community of W1 at data point D1. 9/6/24

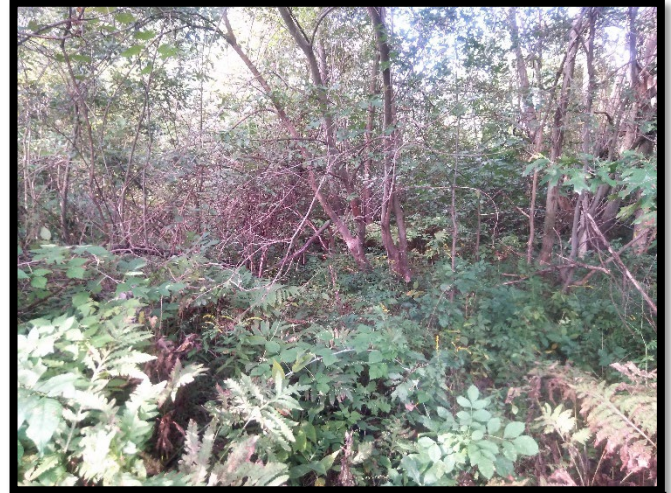
**Photo 2:** Facing west. Depicts the scrub-shrub swamp community of W1 data point D2. 9/6/24

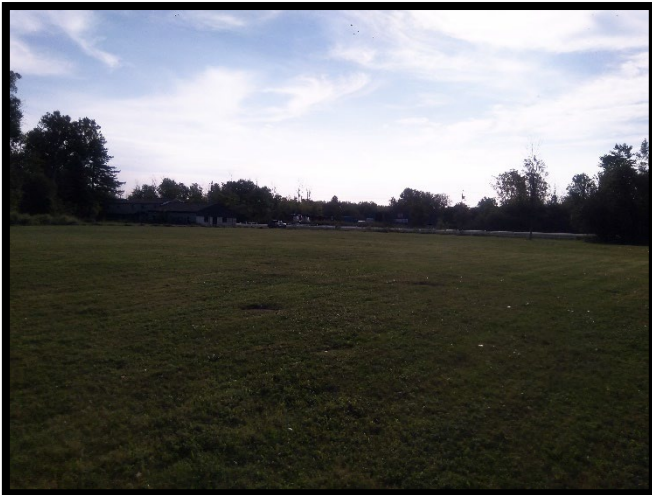
**Photo 3:** Facing southeast. Depicts the mown lawn community of data point D3. 9/6/24
